EM CAMERAS INVALUABLE FOR DIAGNOSING / FIXING PROBLEMS

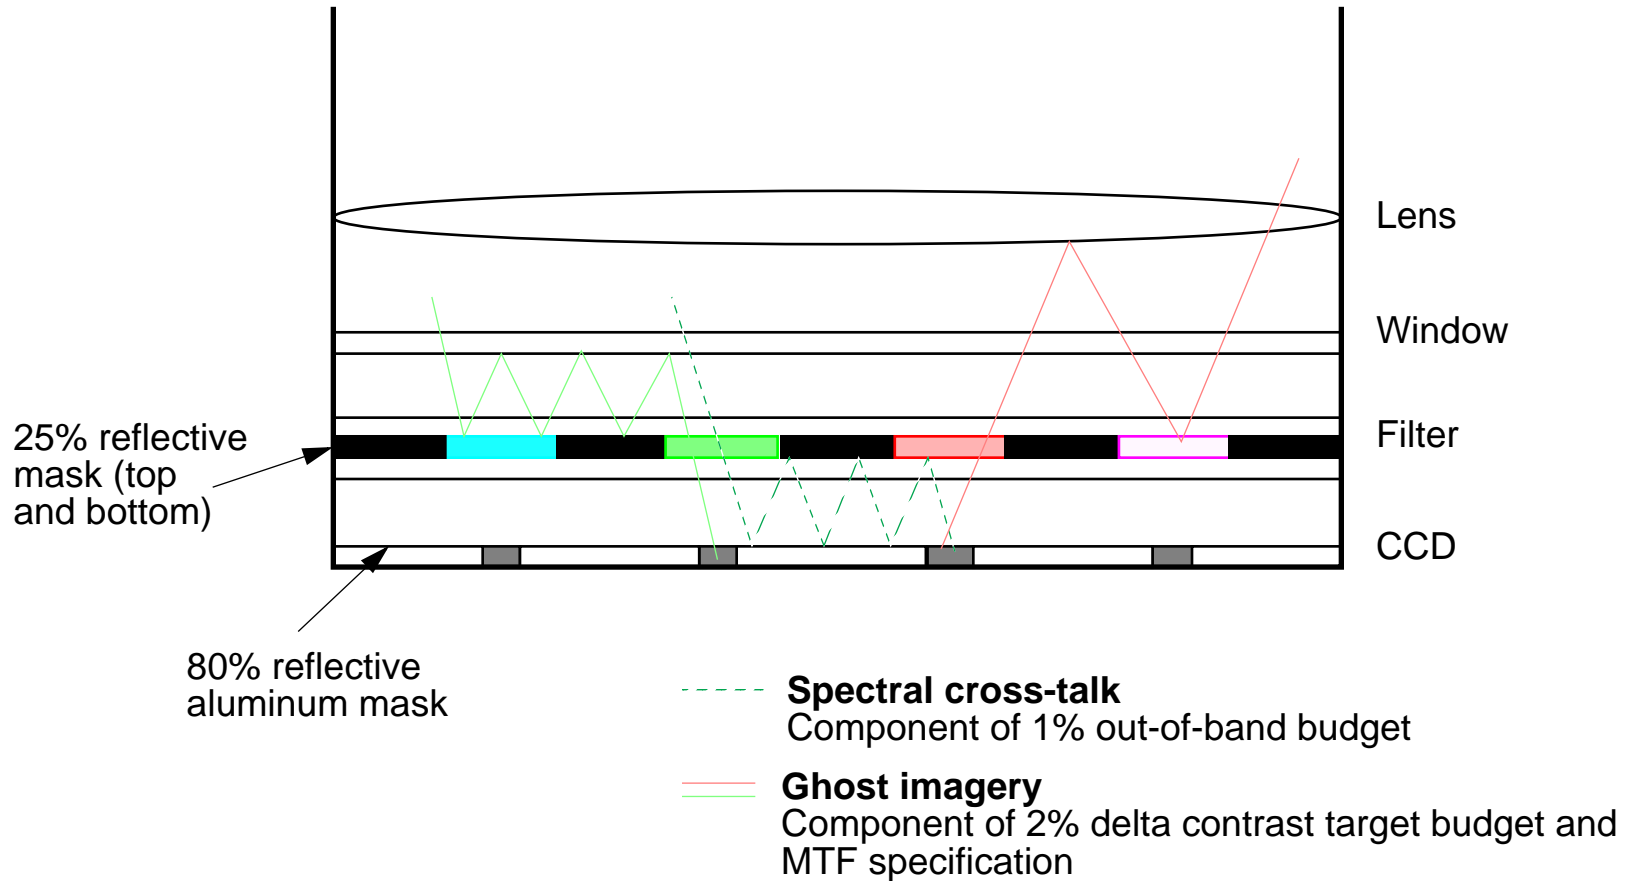
- **Filter scatter sites and CCD/ filter reflections determined to be cause of finite width PSF and out-of-band performance, see:**
 - Korechoff, R.P, D.J. Diner, D.J. Preston, C.J. Bruegge (1995). In Advanced and Next-Generation Satellites. Spectroradiometer focal-plane design considerations: lessons learned from MISR camera testing. EUROPTO/ SPIE Vol. 2538, pp. 104-116, 25-28 September.
